**Inspection Report**  
**Minerals Regulatory Program**  
Report Date: August 8, 2005

**Mine Name:** Little Cottonwood Granite Quarry  
**Operator Name:** Corporation of the Presiding Bishop

**Permit number:** S/035/017  
**Inspection Date:** July 5, 2005  
**Time:** 4:20-4:50 PM

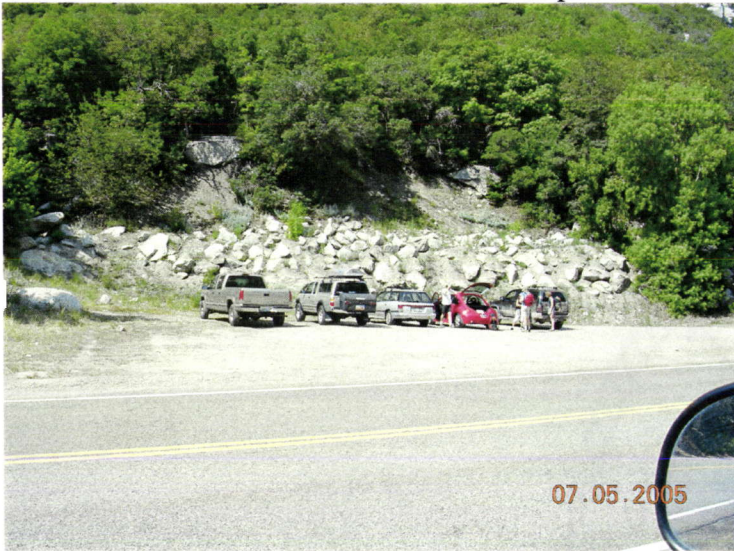
The silt fences, straw bales, twine, and the fence next to the highway have all been removed. The area next to the highway that had been fenced off is being used as a parking area (Photo 1).

**Photo 1.** The parking area at the base of the quarry. There was formerly a fence in front of this area.

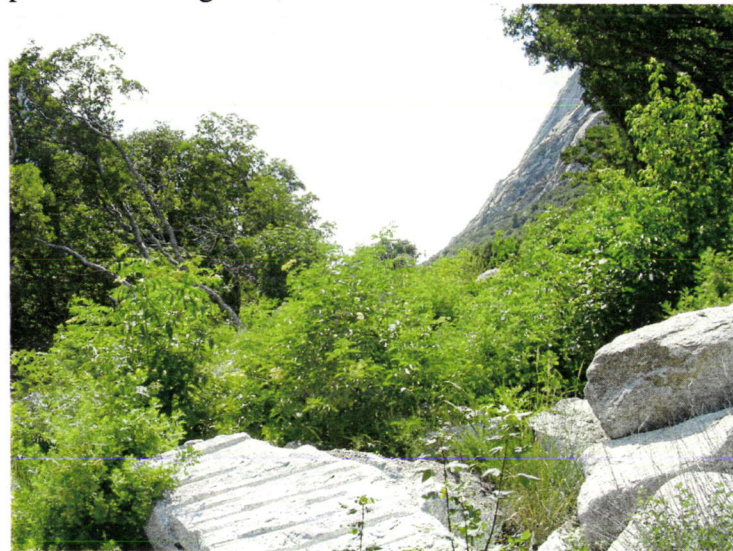
The vegetation has progressed a lot since I last visited the site. Although the woody plants are not yet full grown, they are already providing a lot of cover. Grasses and broadleaf forbs cover most of the remaining areas. Near the top of the quarry are some areas where rock is the predominant cover, but, as can be seen in Photo 4, the adjacent undisturbed areas also have a lot of rock. Species I found in the reclaimed area include elderberry, Wood's rose, big tooth maple, box elder, chokecherry, raspberry, Gambel's oak, Palmer penstemon, basin wild rye, bluebunch wheatgrass, goldeneye, Louisiana sage, and Rocky Mountain penstemon.

**Photo 3.** Note the number and size of the trees and shrubs growing in the reclaimed area.

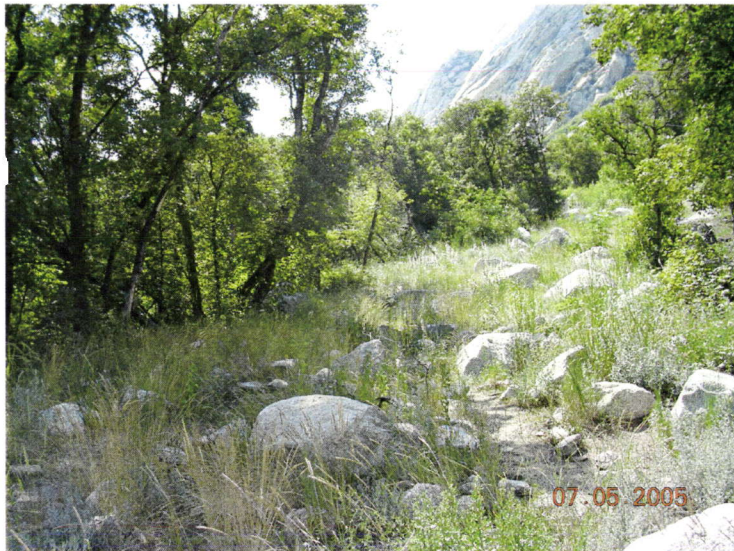
There are trails going up through the disturbed area, but it appears people are staying on the trails rather than damaging vegetation on the entire area (lower right portion of Photo 2).

**Photo 2.** Part of the lower portion of the reclaimed area. Note the trail in the lower right portion of the photo.

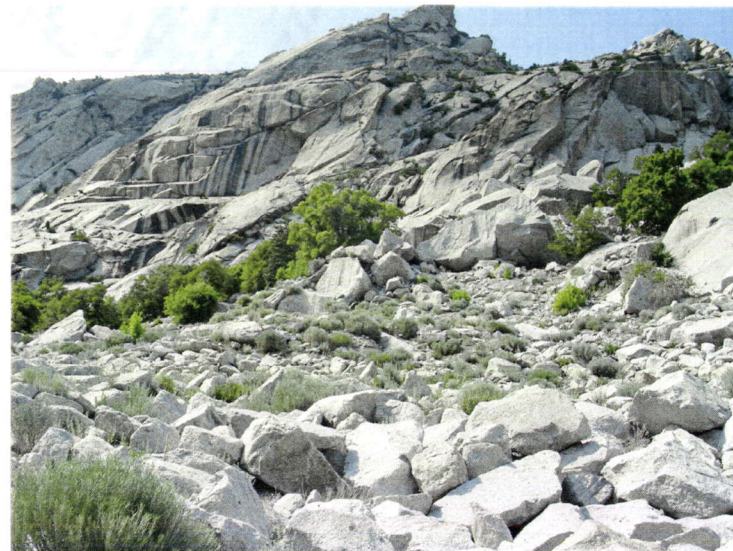
**Photo 4.** The uppermost portion of the reclaimed area.
